**Núria M. Pinyol, Eduardo E. Alonso,  
Jordi Corominas & José Moya**

Landslides (2012) 9:33-51

## Canelles landslide: modelling rapid drawdown and fast potential sliding

**Abstract** A large landslide ( $40 \times 10^6 \text{ m}^3$ ) was reactivated on the left bank of Canelles reservoir, Spain. The instability was made evident after a considerable reduction of the reservoir level. The drawdown took place during the summer of 2006 after several years of high water levels. The drawdown velocity reached values between 0.5 and 1.2 m/day (registered at low elevations). The paper reports the geological and geotechnical investigations performed to define the movement. The geometry of the slip surface was established from the detailed analysis of the continuous cores recovered in deep borings and from limited information provided by inclinometers. Deep piezometric records provided also valuable information on the pore water pressure in the vicinity of the failure surface. These data allowed validating a flow–deformation coupled calculation model, which takes into account the changes in water level that occurred 4 years previous to the failure as well as the average rainfall. The analy

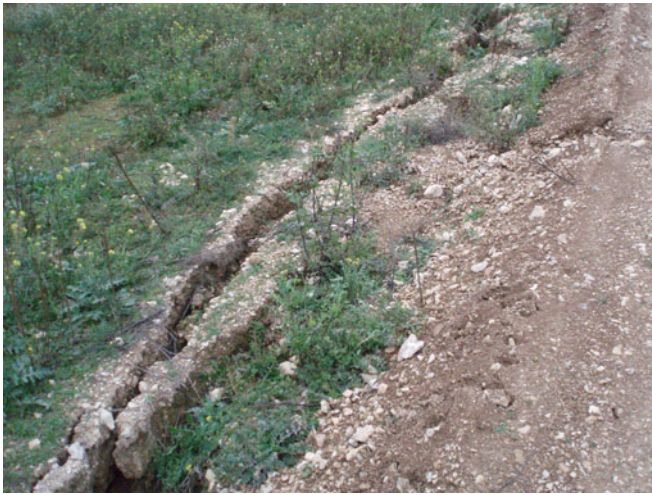
**Fig. 3** Tension crack developed in August 2006 that defines the upper boundary of the slid mass

At a certain point during the summer of 2006, a large landslide was reactivated on the left bank of the reservoir (Fig. 1b). The first indication of instability was the development of a long continuous tension crack (Fig. 3) whose opening varies between 0.1 and 0.3 m. Subsequent investigation, reported in this paper, led to an estimation of the landslide volume of around  $40 \times 10^6 \text{ m}^3$ . The magnitude of the landslide and its potential for sudden acceleration were of special

back crack of the landslide has a length of 1.2 km and it is roughly parallel to the bank of the reservoir. The long tension crack developed at the foot of a continuous scarp 4–5 m high (Fig. 6). The presence of the mentioned tension crack along with the absence

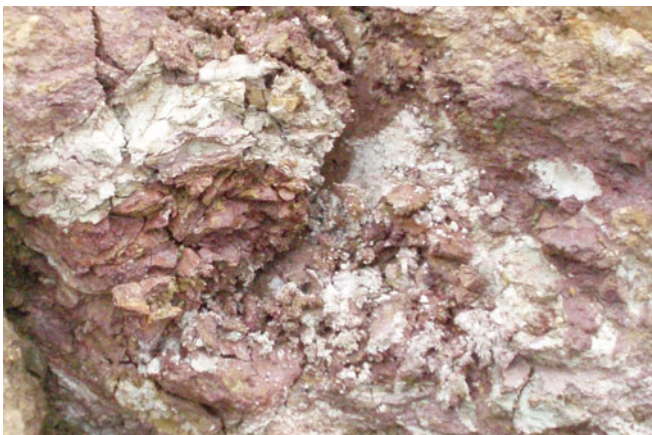
**Fig. 9** Outcrop of the red-wine Garumnian clays

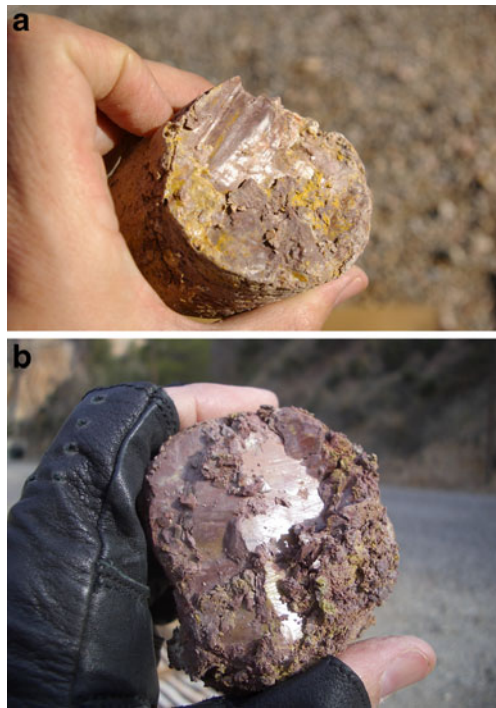
**Fig. 10** Striated and polished surfaces within Garumnian clays recovered in borings a S 3-6 (depth 89.1 m) and b S 3-5 (depth 84 m, see location in Fig. 5)

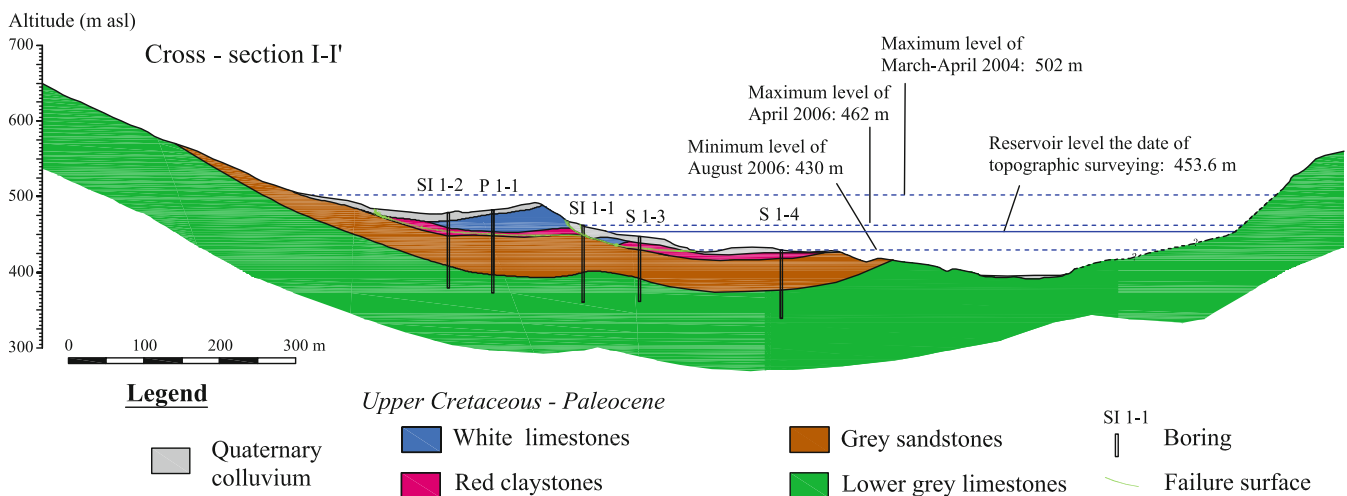
**Fig. 11** Geological cross section I (see location in Fig. 5)

Figures 11, 12 and 13 show the water level of the reservoir at some specific times.

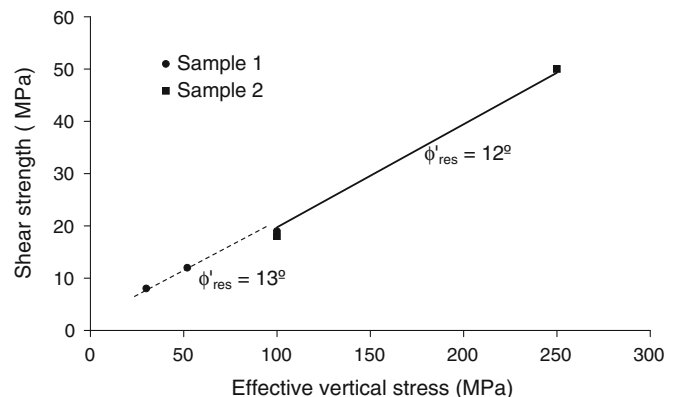
Fig. 14 Residual frictional strength obtained in ring shear test on remoulded Garumnian clay specimens

Since the slide was a reactivation of an ancient failure, residual strength conditions will be acting on the sliding surface. Ring shear tests on remoulded specimens provided the strength envelopes shown in Fig. 14. A residual friction angle of 12–13° was

determined for the range of effective vertical stresses 100–250 kPa. The sliding surface is often located at depths of 50–100 m, and therefore, normal effective stresses prevailing “in situ” are substantially higher (800 kPa in average) than the testing range. In addition, past normal stresses, both of lithostatic and tectonic origin, may have reached also higher than the present values. Therefore, in situ friction angle at the failure surface are probably smaller than the values given in Fig. 14. A likely in situ value is estimated at  $\varphi'_{\text{res}} = 10\text{--}12^\circ$  (Stark and Eid 1994; Alonso 2005).

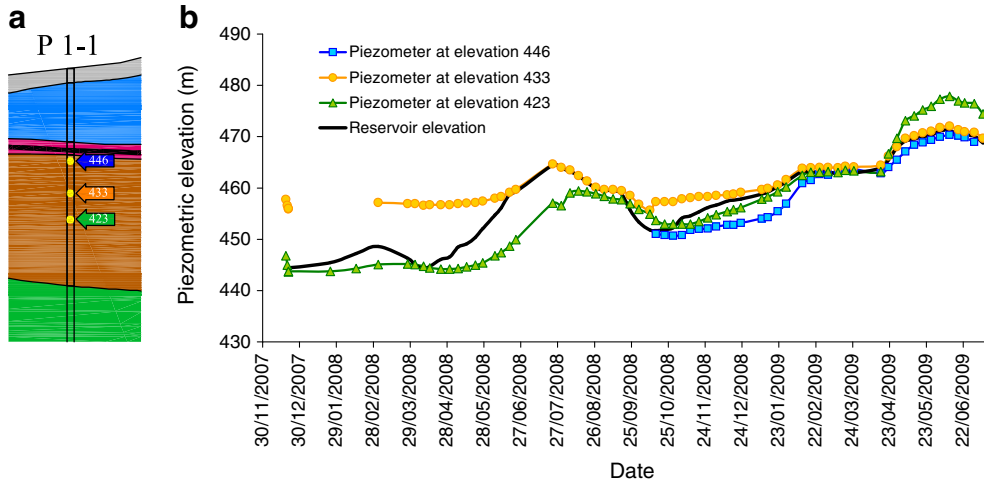
Fig. 15 a Position of piezometers in borehole P 1-1 (see Fig. 5); b piezometer records and reservoir elevation

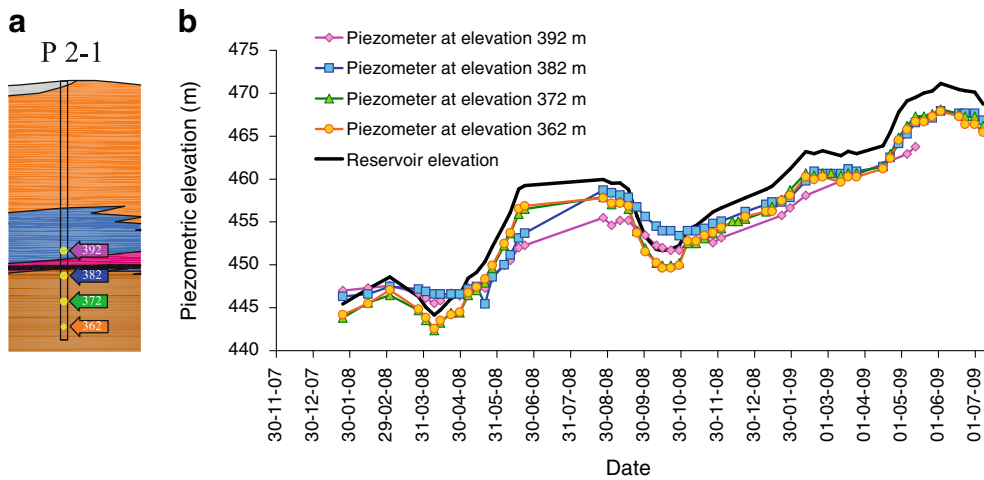
Fig. 17 a Position of piezometers in borehole P 2-1 (see Fig. 5); b piezometer records and reservoir elevation

However, before the analysis of the failure is presented, the calculated pore water pressure will be compared with piezometer measurements recorded after the failure in order to check the reliability of results. Figures 26, 27 and 28 show such comparison for the piezometers installed in cross section II (see their position in Figs. 5, 17a, 18a and 19a).

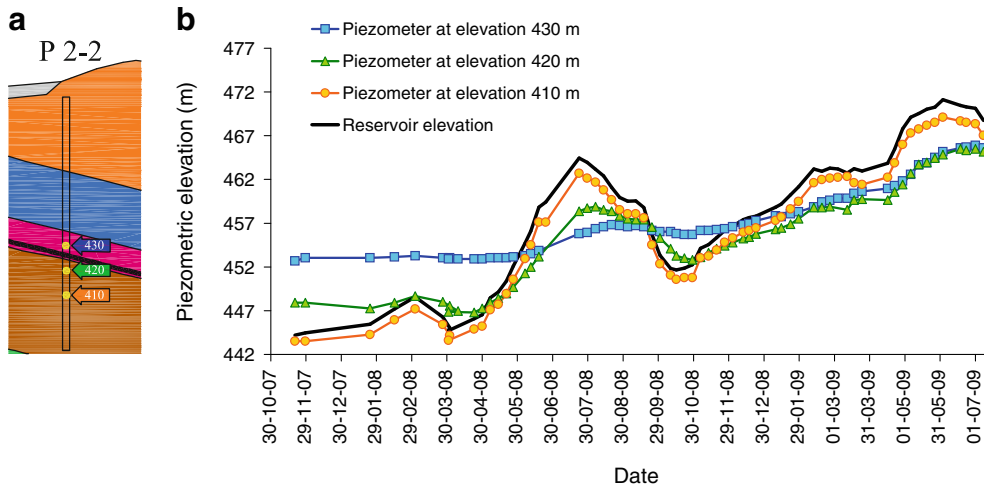
Fig. 18 a Position of piezometers in borehole P 2-2 (see Fig. 5); b piezometer records and reservoir elevation

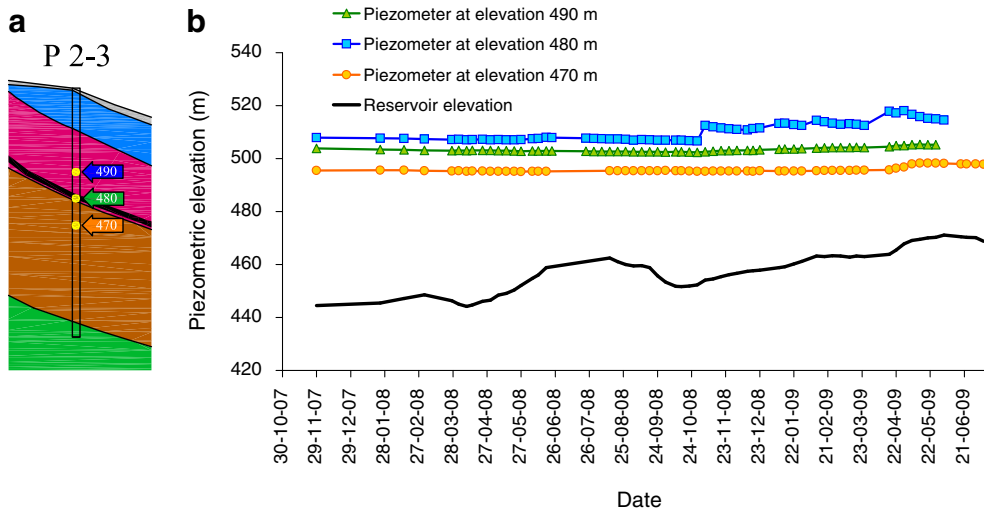
Fig. 19 a Position of piezometers in borehole P 2-3 (see Fig. 5); b piezometer records and reservoir elevation

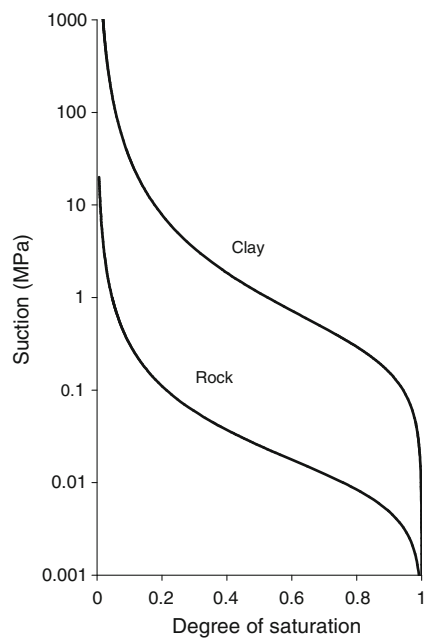
**Fig. 21** Retention curves used in calculation

The analysis requires the characterization of materials under unsaturated conditions. The retention curves introduced in the calculations use the Van Genuchten model having the parameters indicated in Table 1 and plotted in Fig. 21. Relative permeability is defined according to the cubic law ( $k = k_{sat} k_{rel} = k_{sat} S_r^3$  where  $k_{sat}$  is the saturated permeability and  $S_r$  is the degree of saturation) for both materials.

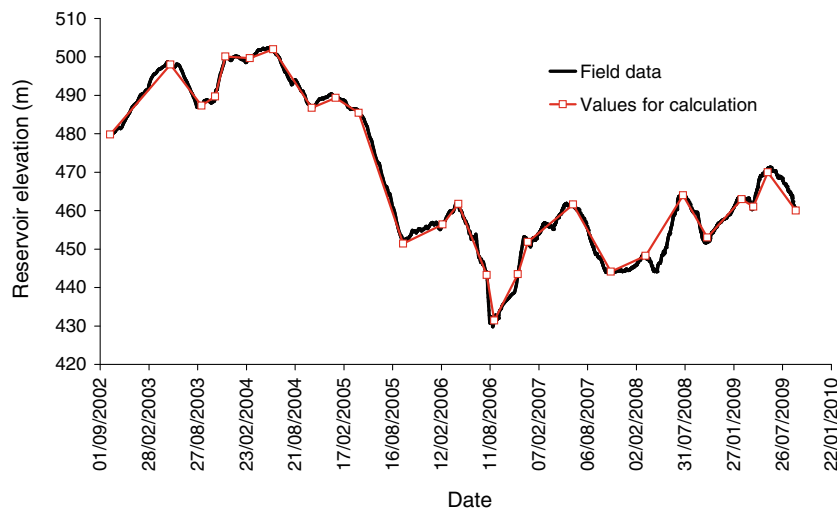
**Fig. 22** Time variation of reservoir level

The known history of water level elevation was modelled during the 4 years prior to the drawdown that probably caused the failure and it was then continued until July 2009 (Fig. 22). This allows establishing the pressures acting on the failure surface with the purpose of analysing the stability at any time. In addition, the measurements taken in the piezometers installed in November 2007 could be compared with calculations in an effort to validate the numerical model. The initial pore water pressure assumed in the calculation is a horizontal hydrostatic profile.

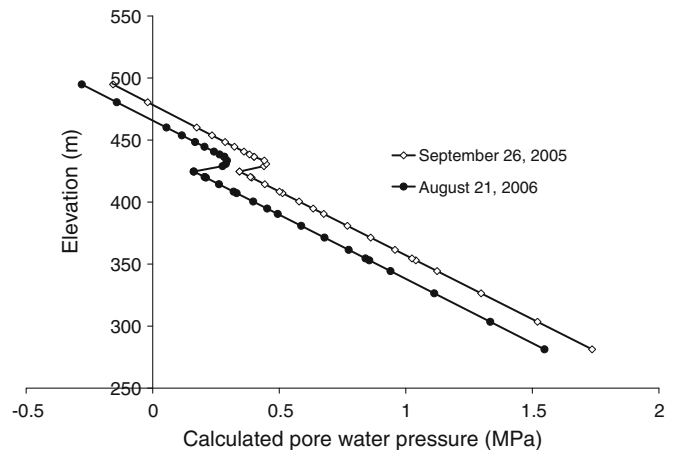
Fig. 25 Calculated pore water pressure distribution along the vertical profile located at the position of SI 1-2 (see Fig. 5) on September 26, 2005 and August 21, 2006 when reservoir elevation was at 451 and 431 m, respectively

by the abrupt change of the contours. This can be clearly observed in Fig. 25, which shows the calculated pore water pressure along a vertical cross section located in the position of P 2-2.

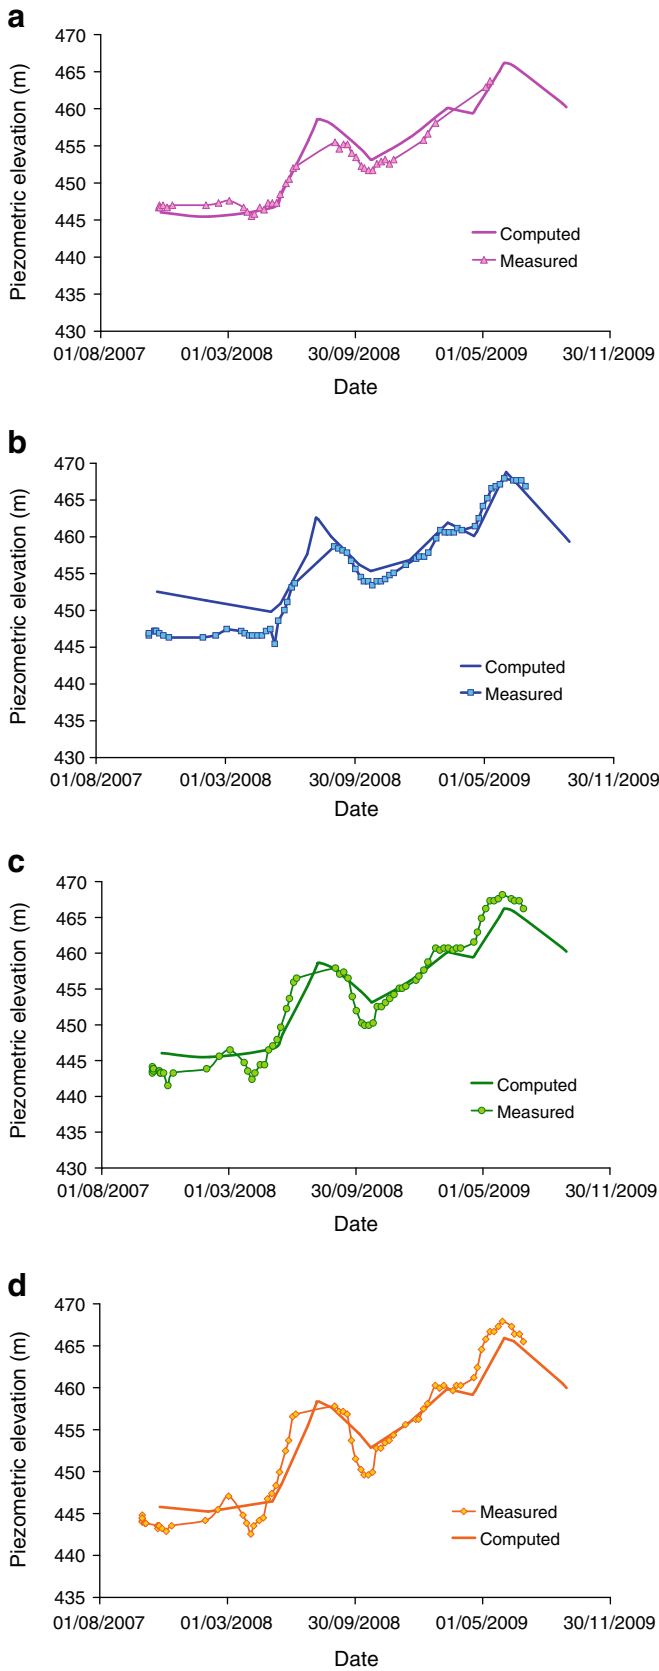
**Fig. 26** Comparison of calculated and measured pore water pressure in piezometers located in boring P 2-1 at elevation a 392 m, b 382 m, c 372 m and d 362 m

Pore water pressures measured within the lower sandstone in P 2-1 and P 2-2, which follow precisely the reservoir elevation evolution, are well captured by the calculation. This is a consequence of a correct choice for sandstone permeability. Pressure measurements within the

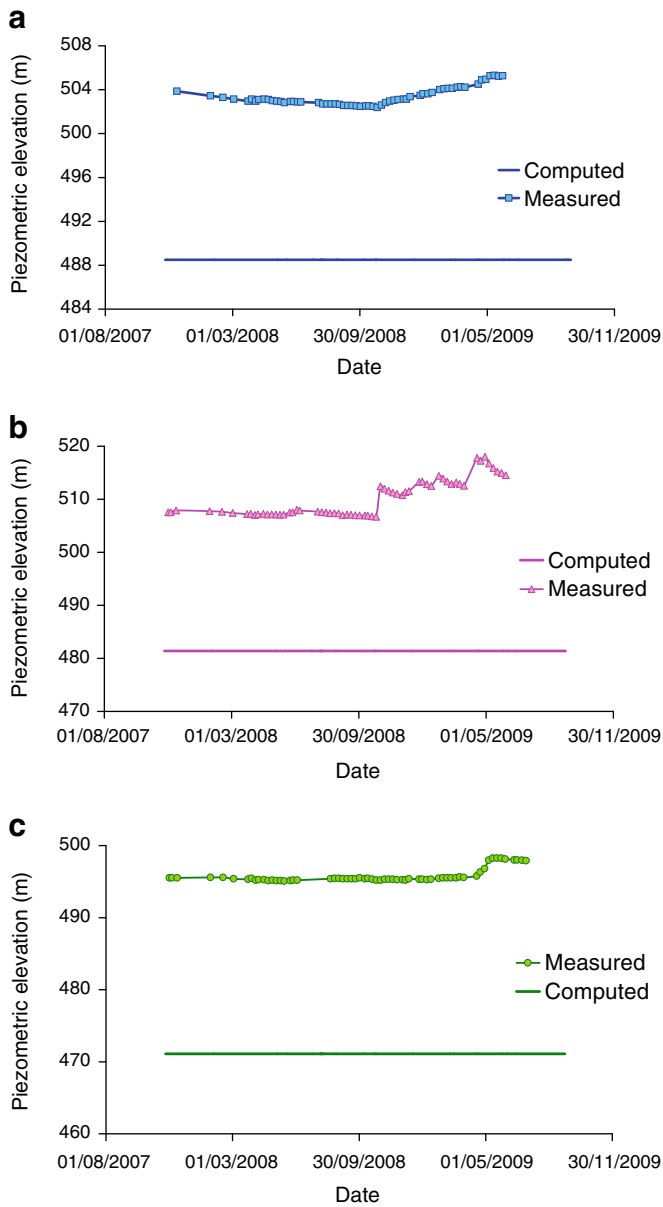
**Fig. 28** Comparison of calculated and measured pore water pressure in piezometers located in boring P 2-3 at elevation **a** 489.87 m, **b** 480.07 m and **c** 469.87 m
